APOLLO 16 MISSION

ANOMALY REPORT NO. 6

REACTION CONTROL SYSTEM
HELIUM PRESSURE REGULATOR FILTER FAILURE

MANNED SPACECRAFT CENTER
HOUSTON, TEXAS
DECEMBER 1972

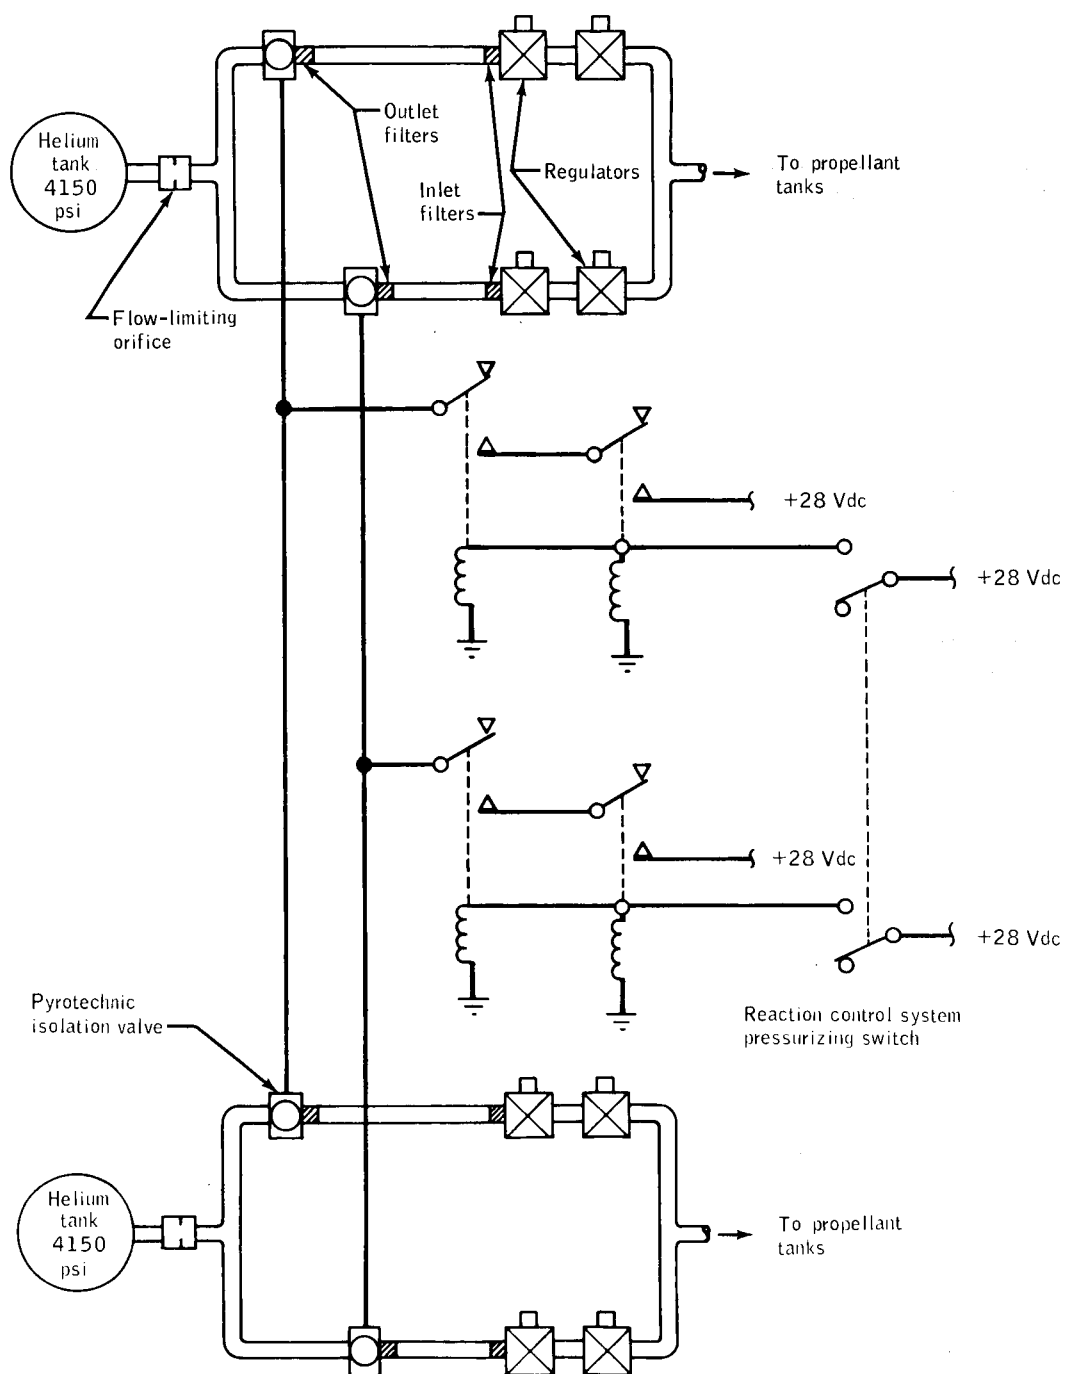
Figure 1.- Helium pressurization for reaction control system.

At system activation, the pyrotechnic isolation valves are operated in pairs by two different relay circuits (fig. 1). Differences in relay pull-in times and valve actuation times may result in 2 to 3 milliseconds difference between valve opening times.

When the first valve opens, a pressure surge propagates from the valve to the inlet side of the two series regulators. The surge is driven by the helium tank pressure of 4150 psi. If the second valve opening is delayed by 2 milliseconds, a pressure surge also propagates from the second valve to the inlet of the regulators in that leg, but the driving pressure will be only 2500 psi since the flow limiting orifice in the helium tank outlet line will not pass enough helium in 2 milliseconds to maintain the valve inlet manifold pressure. The pressure surges will affect the filters in both regulator legs of each pressurization system, but the filter receiving the surge with the larger driving pressure will be most affected.

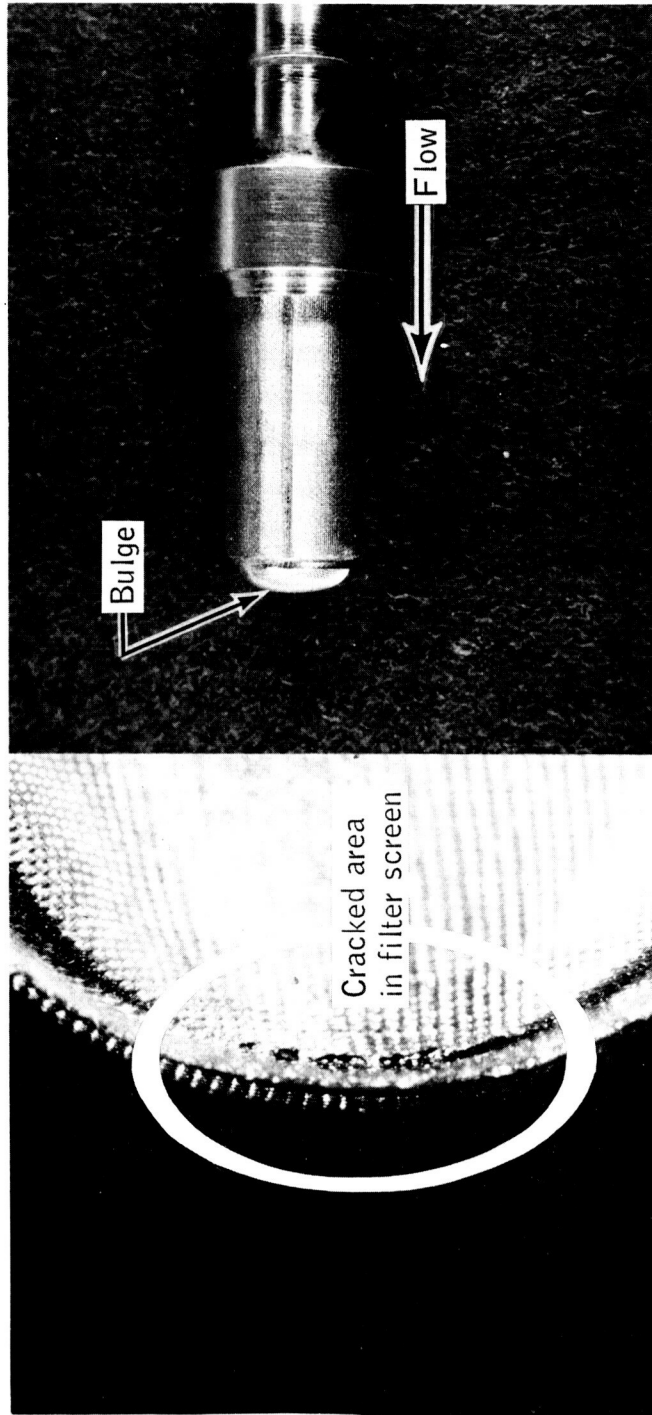
Figure 3.- Reaction control system regulator filter.

The regulator inlet filter end caps were found bulged 0.005 to 0.070 inch beyond the edge of the weld lip (fig. 3). About 5 percent of the wire strands in one of the filters were broken and the rating of the filter was increased from 25 to 94 microns. The broken strands were warp wires (fig. 4) and the breaks were ductile separations.

(a) Front view showing cracked edge.

(b) Side view showing deformed end.

The filter element end caps were bulged by the helium pressure surge during activation. Some end caps may bulge and also some wire separation may occur during future command module reaction control system activations; however, system performance should not be affected.

The reaction control system design is acceptable and no change in hardware, system, or activation procedures is required.

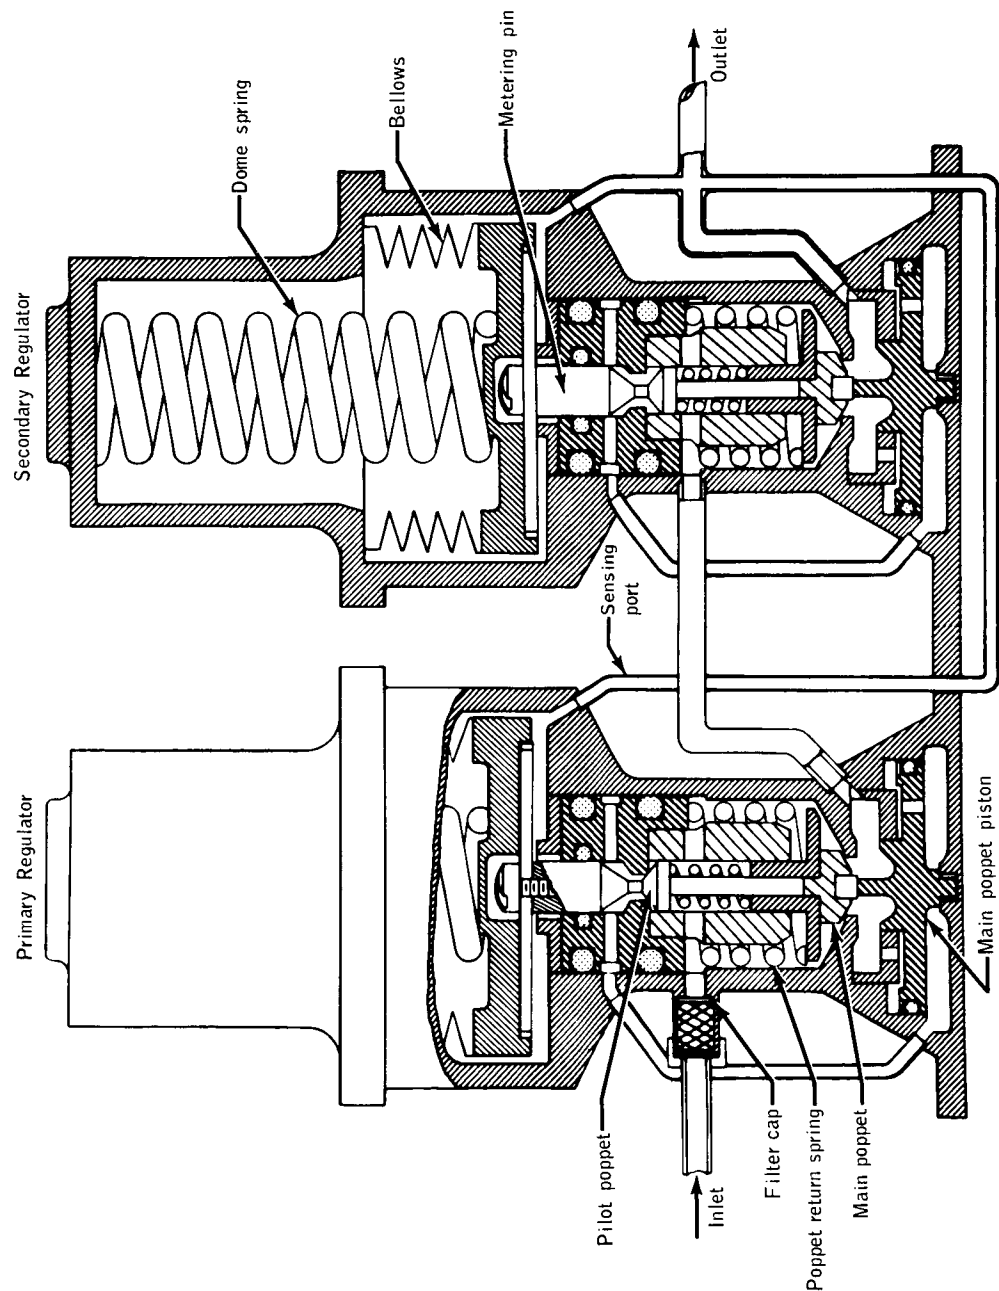
Figure 5.- Cross-section of reaction control regulator.

If the entire filter and cap should break, the end cap would move into the regulator and most likely be trapped within the regulator body by the poppet return spring (fig. 5). If somehow the screen jammed in the main poppet seat, the secondary regulator would control the pressure.
